Service bulletin # HK2010-01 June 2010

Models: HKTS2, HKTS5, HKTS6, HKTS7, HKTS8, HKTS15

Subject: Repetitive Popping/Thumping Sound When In Standby

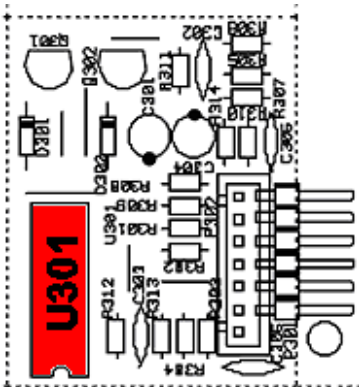
- 1) Remove the amplifier from the cabinet
- 2) Locate the limiter board; remove adhesive from rear side of the PCB so you can access U301.

3) Replace U301 (IC TL074CN ST Quad Op-Amp) on the limiter board with hk part# 190-16TL1074CN or equivalent.
